Subject: Correspondence Regarding Group III (Email 7), Freedom of Information Act (FOIA) Request DON-NAVY-2017-

003161 - Camp Lejeune - P1383 & P1384 Base Entry Point / CLEO Building Projects Contract No. K1310-002-S /

Project Number K1310 SLO Case No. 16-970

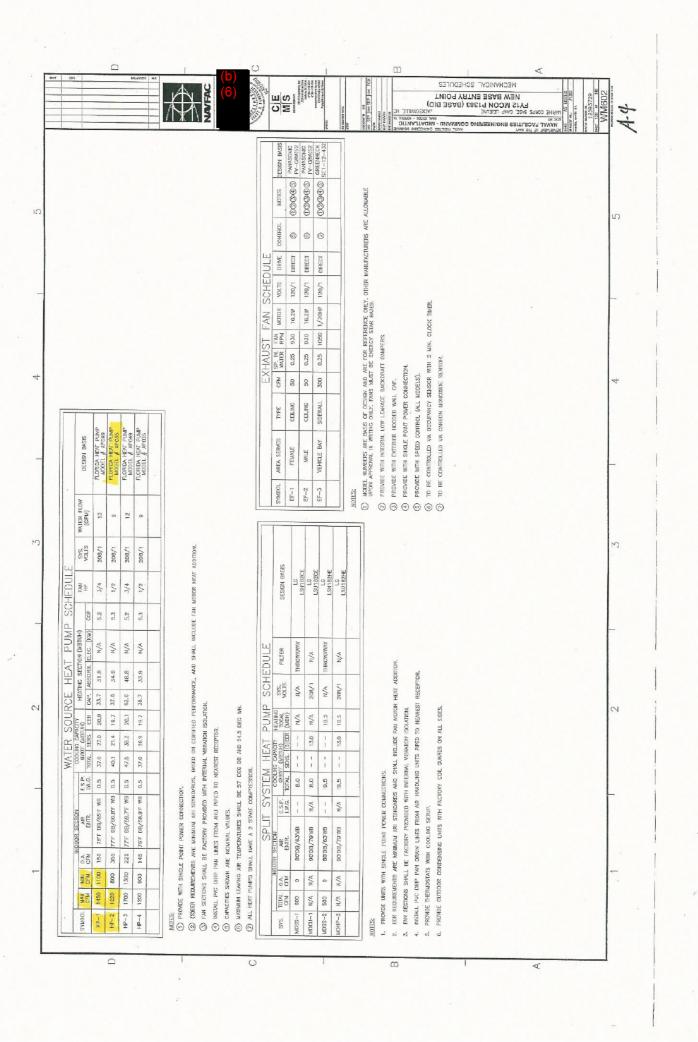
Performance based on ARI/ISO rated air flow, fluid flow and voltage. For conditions other than rated, consult the EAD selection software. Due to variations in installation actual performance may vary marginally from tabulated values.

3512 Cavalier Dr. Ft. Wayne, IN 46808 Phone: 877-443-6411 Fax: 260-482-1489

www.geoexcel.com

All entering air conditions are 80°F DB and 67°F WB in cooling, and 70°F DB in heating.

AHRI/ISO certified conditions are 80.6°F DB and 66.2°F WB in cooling and 68°F DB in heating.

Table does not reflect fan or pump power corrections for AHRI/ISO conditions.

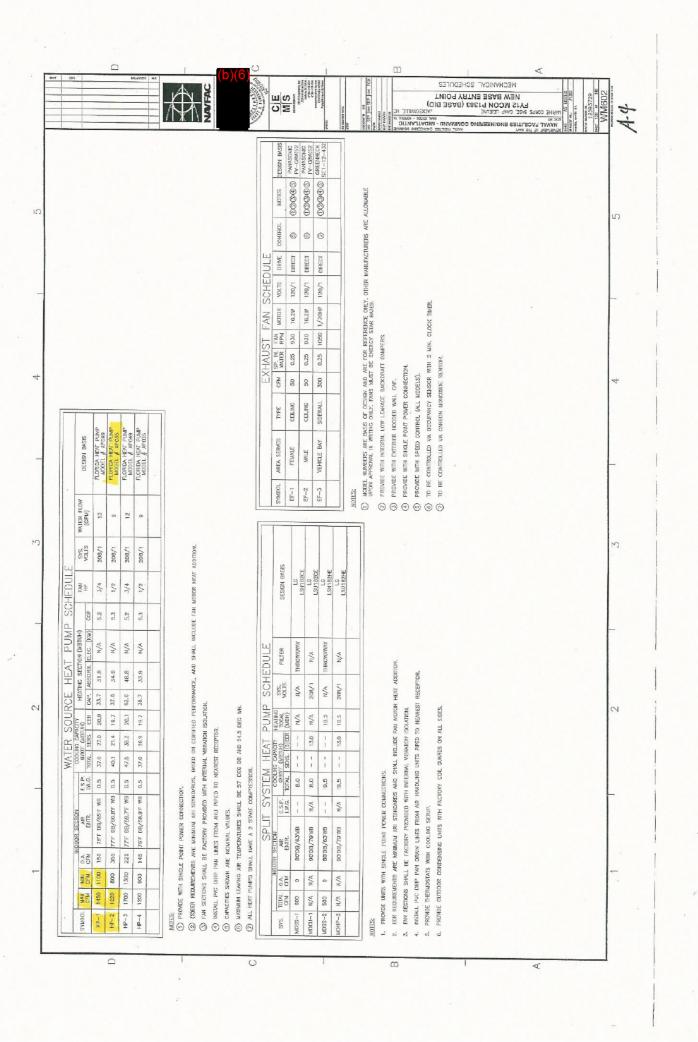
Performance based on ARI/ISO rated air flow, fluid flow and voltage. For conditions other than rated, consult the EAD selection software. Due to variations in installation actual performance may vary marginally from tabulated values.

3512 Cavalier Dr. Ft. Wayne, IN 46808 Phone: 877-443-6411 Fax: 260-482-1489

www.geoexcel.com

All entering air conditions are 80°F DB and 67°F WB in cooling, and 70°F DB in heating.

AHRI/ISO certified conditions are 80.6°F DB and 66.2°F WB in cooling and 68°F DB in heating.

Table does not reflect fan or pump power corrections for AHRI/ISO conditions.
